# **The Corrowong Wallendibby Erosion and Sediment Control Project 1995-2001: Benchmarking Report**

Prepared 2007 by Emma Platts, on behalf of the Corrowong Wallendibby Landcare Group Inc.

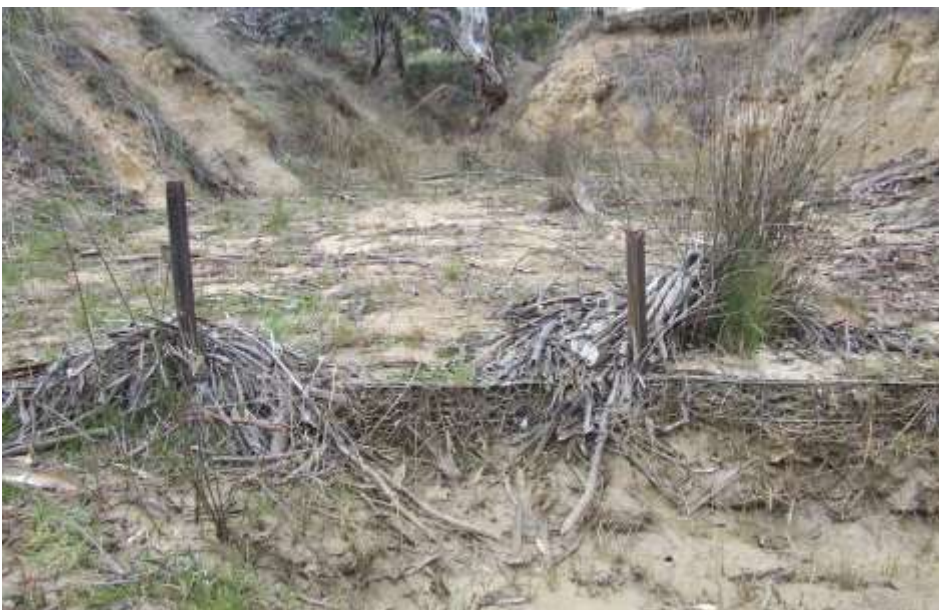
Figure 14: Wire mesh weir at capacity at Hollyridge. Again note the elevation of the gully floor with retained sediment (figure Emma Platts 2007).

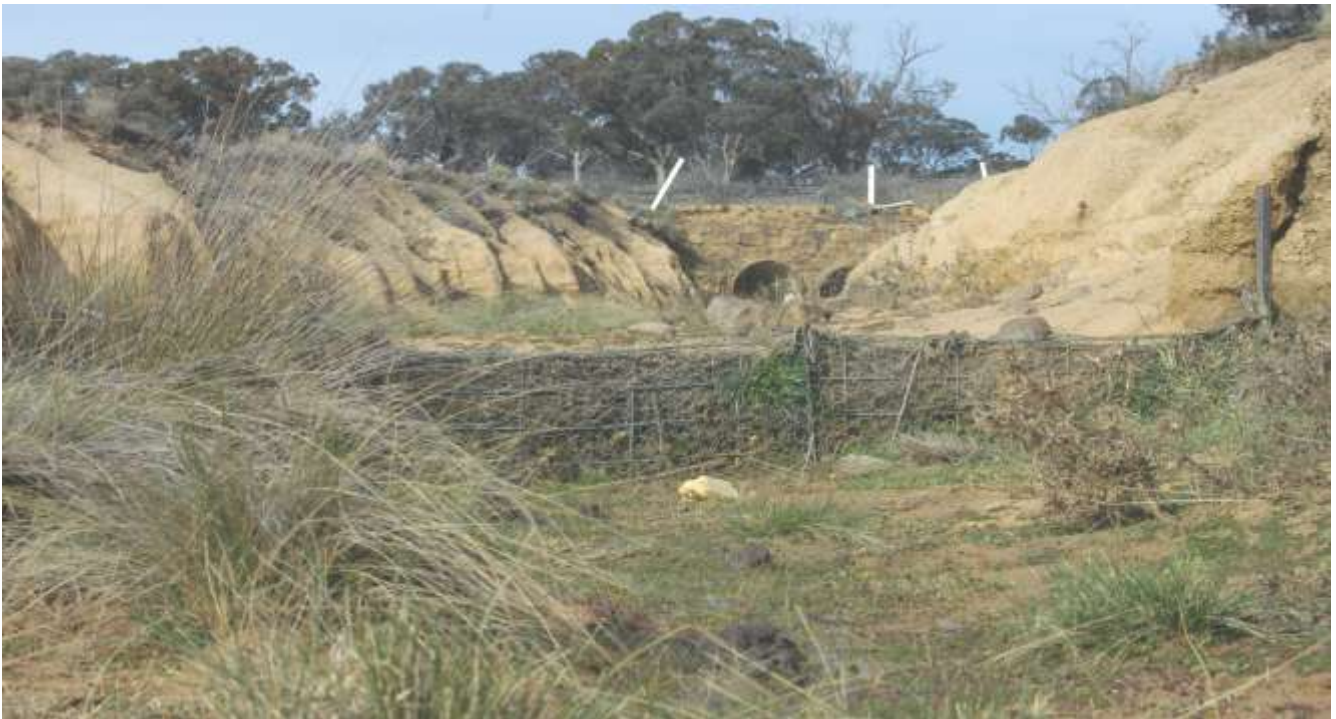
Figure 15: This sediment trap at Kangaroo Ground has reached capacity and is in need of replacement. Again note the effectiveness of the trap in mitigating sediment and elevating the level of the gully floor. Revegetation is better able to establish on the trapped sediment, especially where stock access is managed.

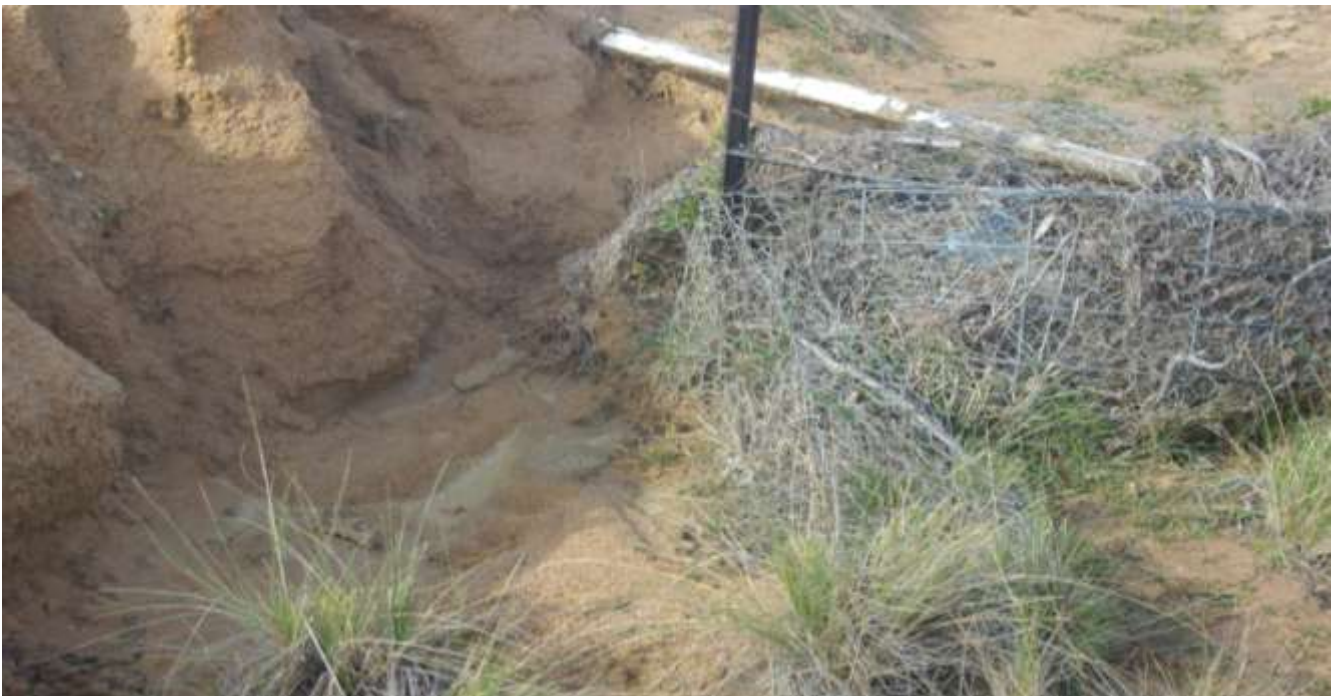
Figure 16: As well as reaching capacity, many sediment traps have minor repair issues. Most have occurred where built up sediment and debris obstructs the flow of water after a rainfall event; an alternative pathway then erodes the weakest point of the structure, usually at the side (as is the case above). Although reducing the overall effectiveness of the structure, it is not of significant concern, (especially given the large number of structures) except where concentrated flow causes bank scouring.

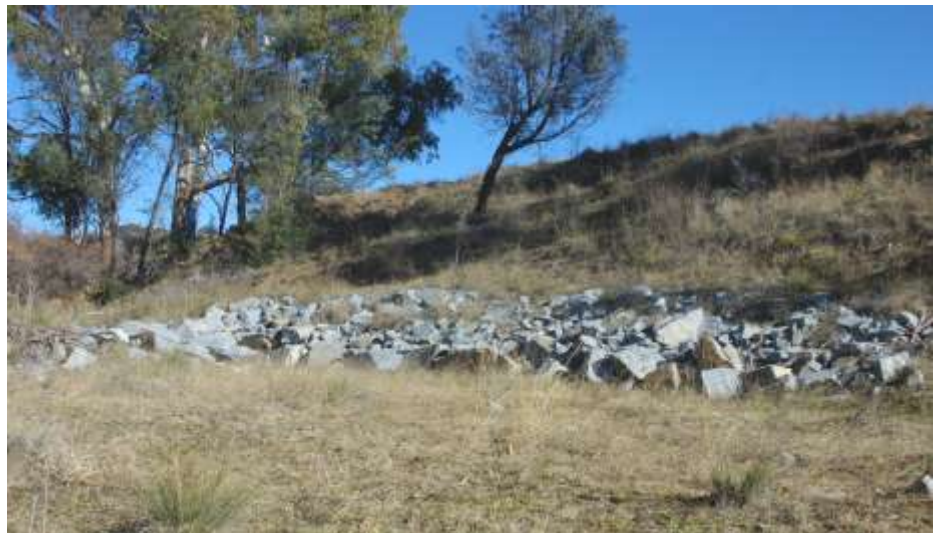
Figure 18: This figure demonstrates the finite capacity of rock groynes in relation to sediment input. This rock groyne at Corrowong, (which plays a final sediment retainment role before water is delivered to Corrowong Creek), is close to sediment capacity. Such a structure would benefit from the installation of a number of wire mesh weirs in the gully line above.

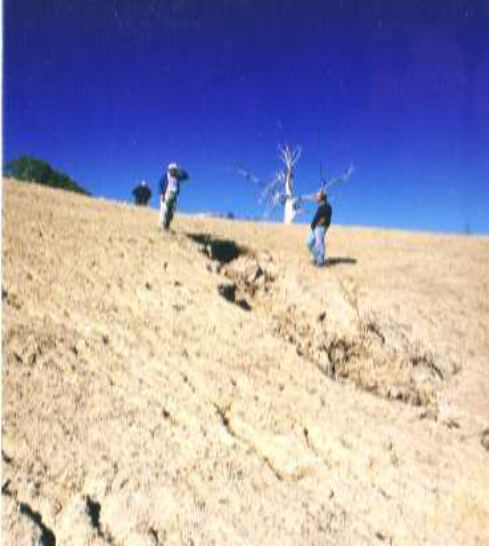
Drought conditions provided less than optimal conditions for dam wall compaction, as demonstrated in **Figure 19** . Despite this all sediment basins (and dams for erosion control purposes) have proved successful1. **Figure 20**. Note the colour of the water, indicating sediment input.

Figure 19: Rilling dam wall at Bimbimbie (source and date unknown).

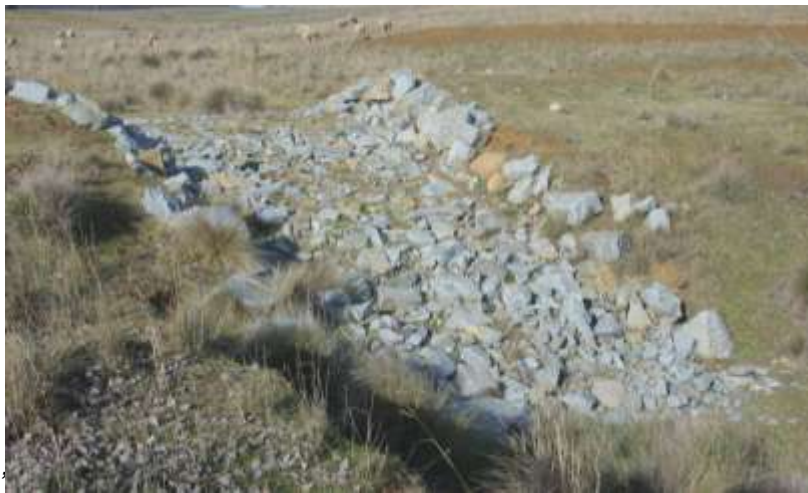
Figure 23: The same flume at Greenfields in 2007. The flume has withstood overland flow and grassed up well – note that this is in a moderate energy environment (figure courtesy Sally Anne Thompson 2007).

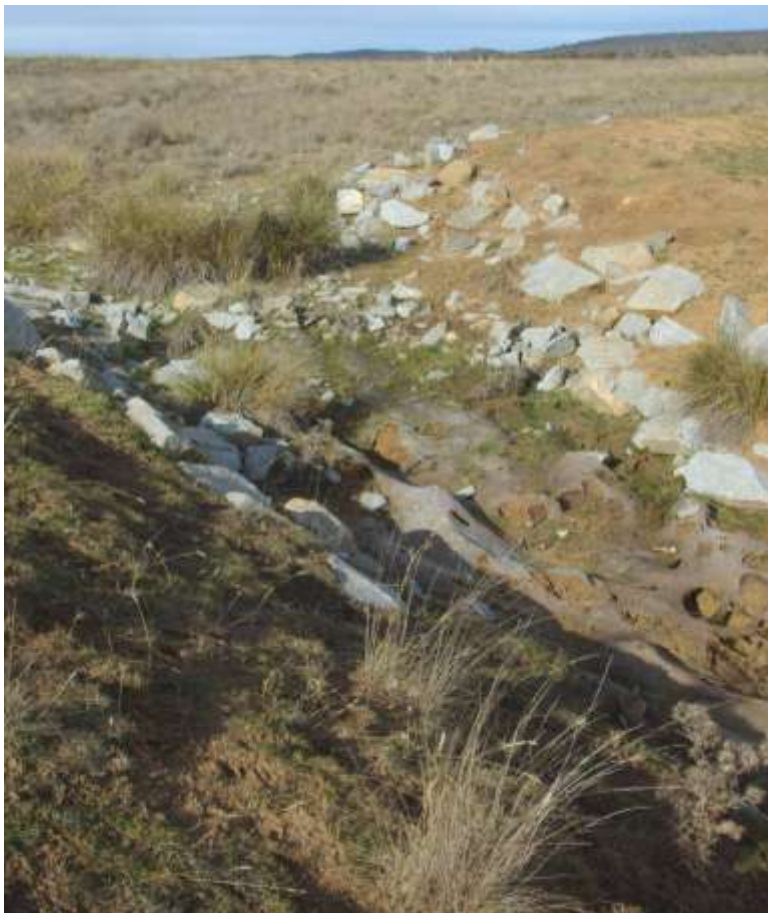
Flumes were used in numerous instances in place of concrete as a lower cost but higher risk option; consequently there has been a mix of success and some disappointing failures. Rock flumes proved successful in low to moderate energy flow environments, in the upper part of catchments where the vertical drop is no more than two metres. Compromises in grade and rock size (due to a limited budget) along with too steep batter grades (particularly on larger flumes) have resulted in several failures (see figures 25 and 26).

Figure 25 (right): A failed rock flume at Greenfields. Note the exposure of geotextile and movement of rock. Evidently rock selection was too small to withstand the velocity of overland flow after an intense summer storm. This flume will need complete repair, including re-battering by excavator, geotextile and a greater diameter of rock. Fortunately the diversion banks are intact and have grassed up adequately (figure courtesy Sally Anne Thompson 2007).

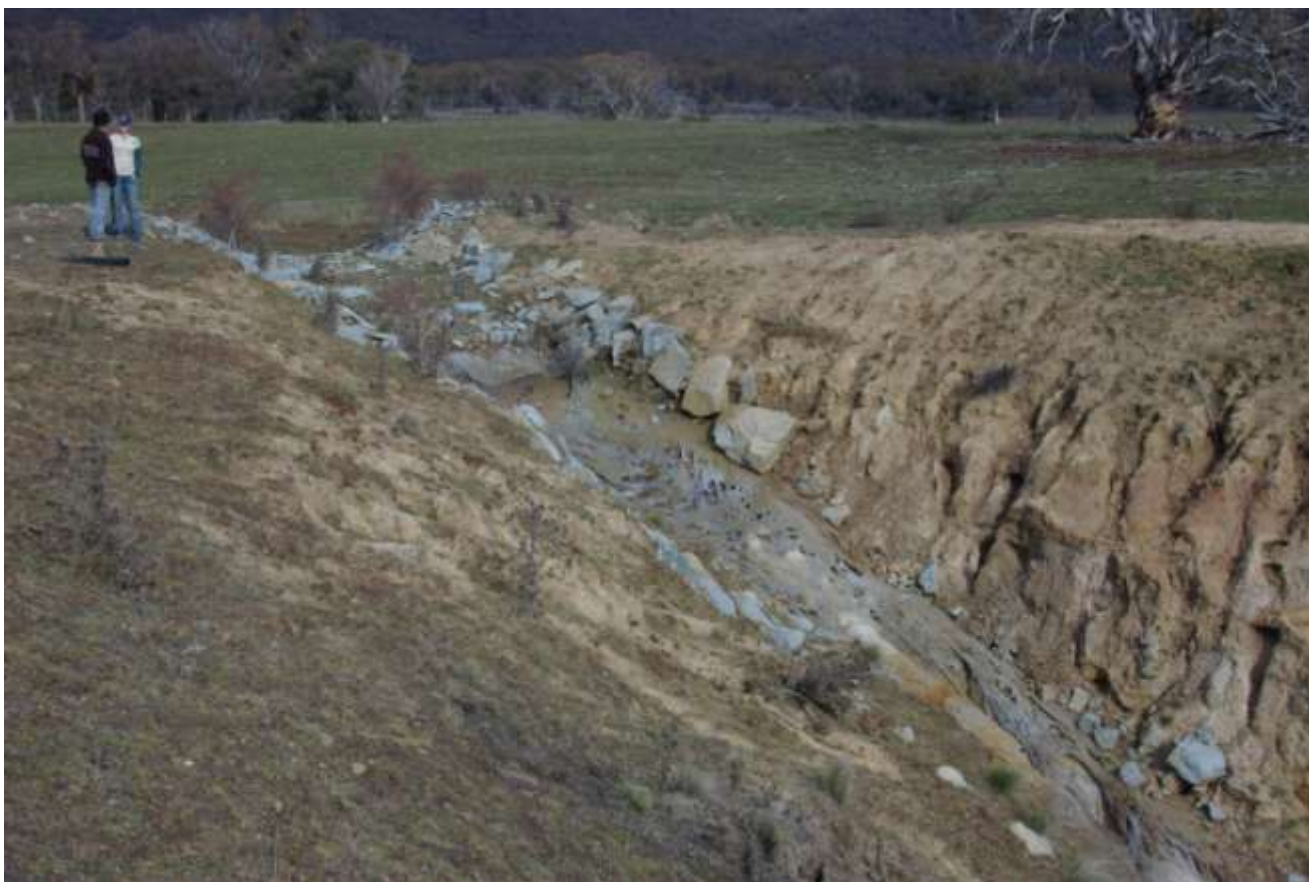
Figure 26 (below): Greg Walker (landowner) and Emma Platts, discuss a failed flume at Avondale. This failure was due to inadequate rock size combined with too steep batter grades. Note the movement of rock and the exposure of geotextile. The batter banks are actively eroding as a result (figure courtesy Emma Platts 2007).

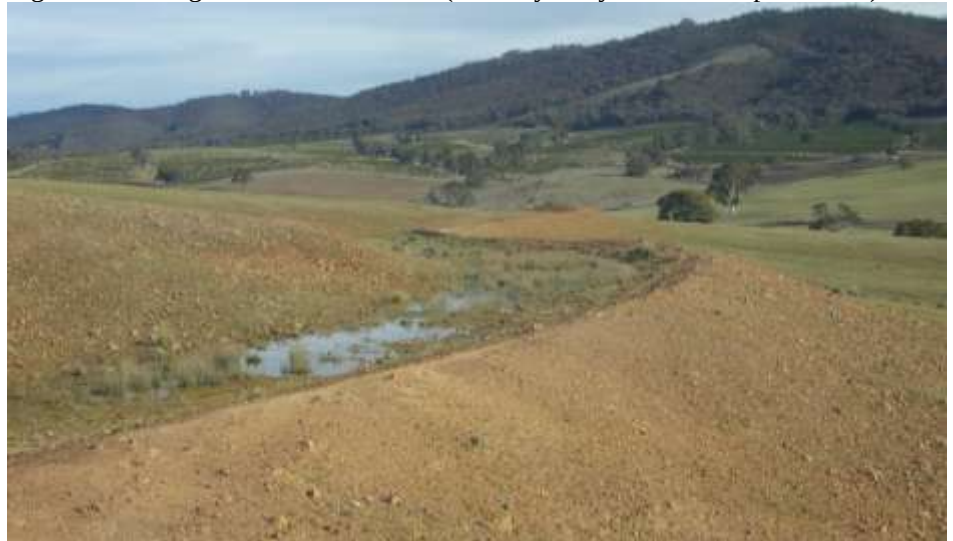
Revegetation on soil conservation structures has been variable and depends on a number of factors, including position in the catchment, aspect, stock pressure and the nature of the top soil. Some diversion banks such as figure 28 will never grass up.

Figure 28: Diversion bank, Corrowong (figure courtesy Emma Platts 2007)

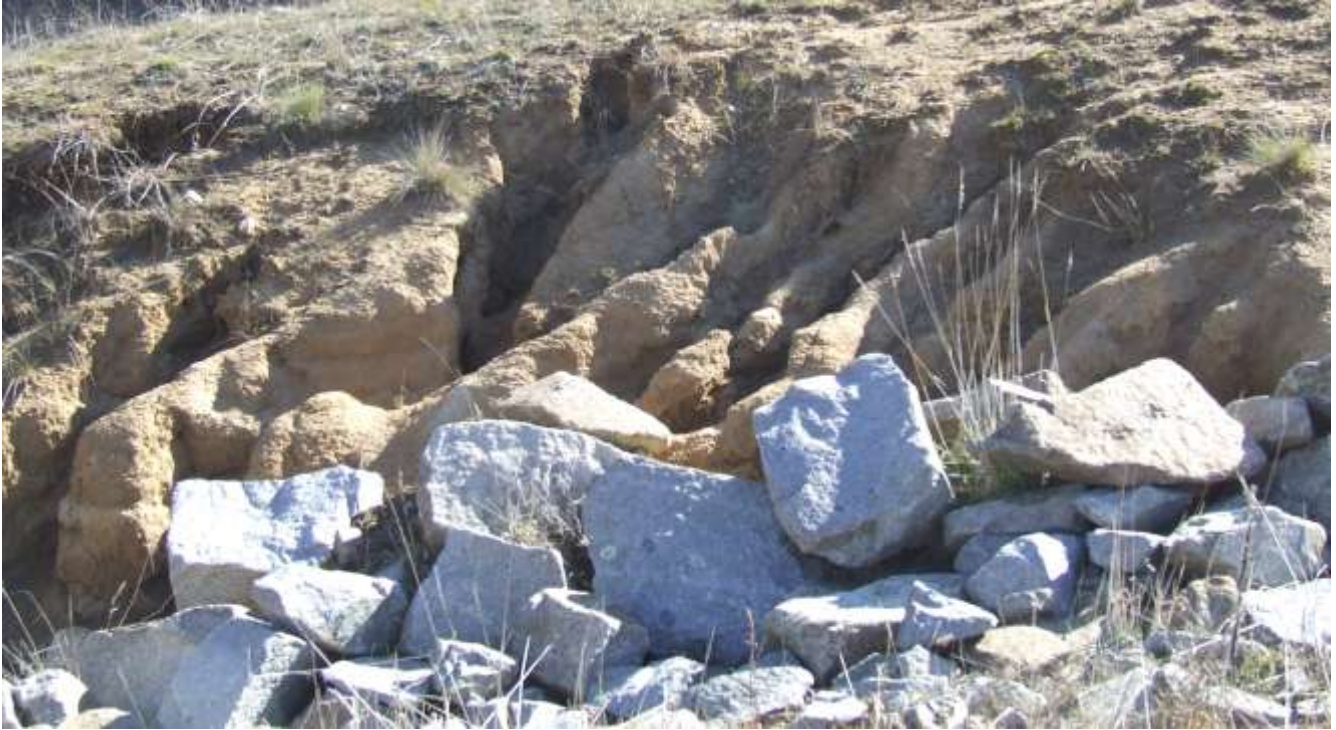
Figure 34: The outer edge of a rock flume at Ron Reed's property Woodborough. Overland flow has eroded along the edge of the rock armour causing further erosion.

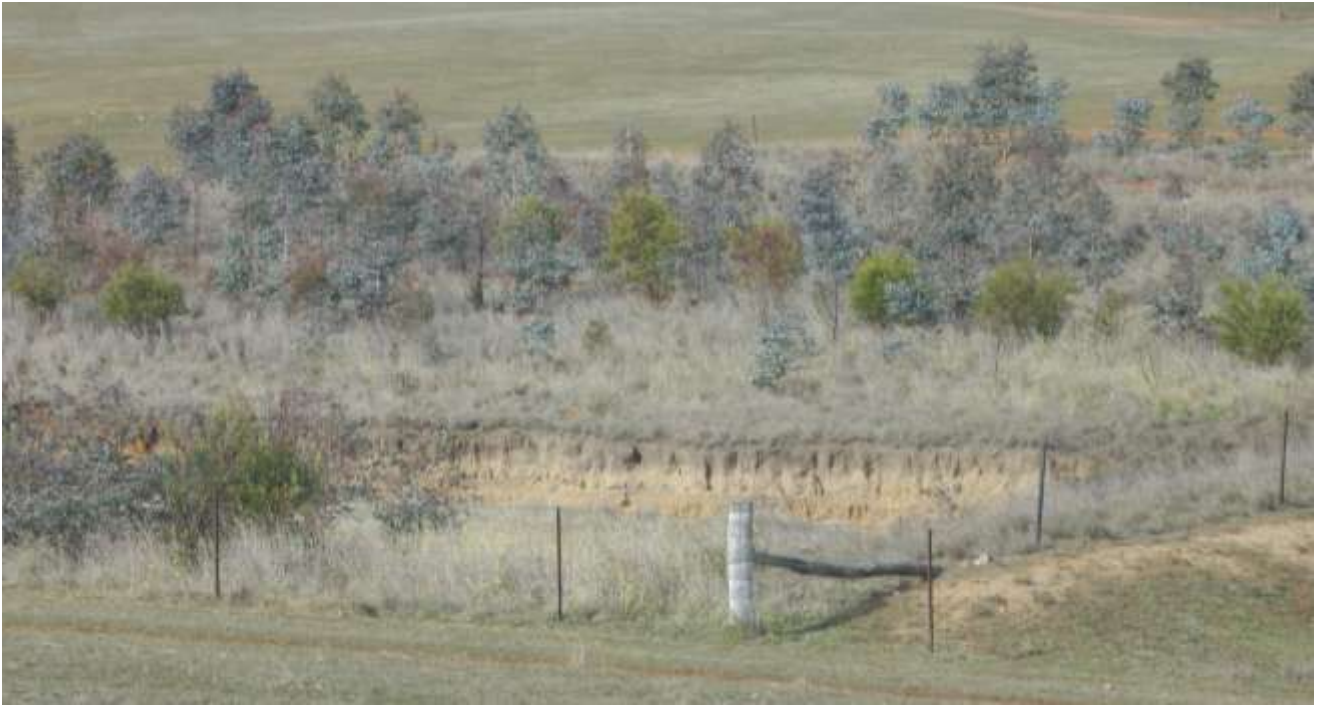
Figure 35: A fenced and revegetated gully at Wallendibby. Note the lack of vegetation on banks. This is endemic throughout most gullies, where steep vertical banks present less than optimal conditions for grass to establish (courtesy Sally Anne Thompson 2007).

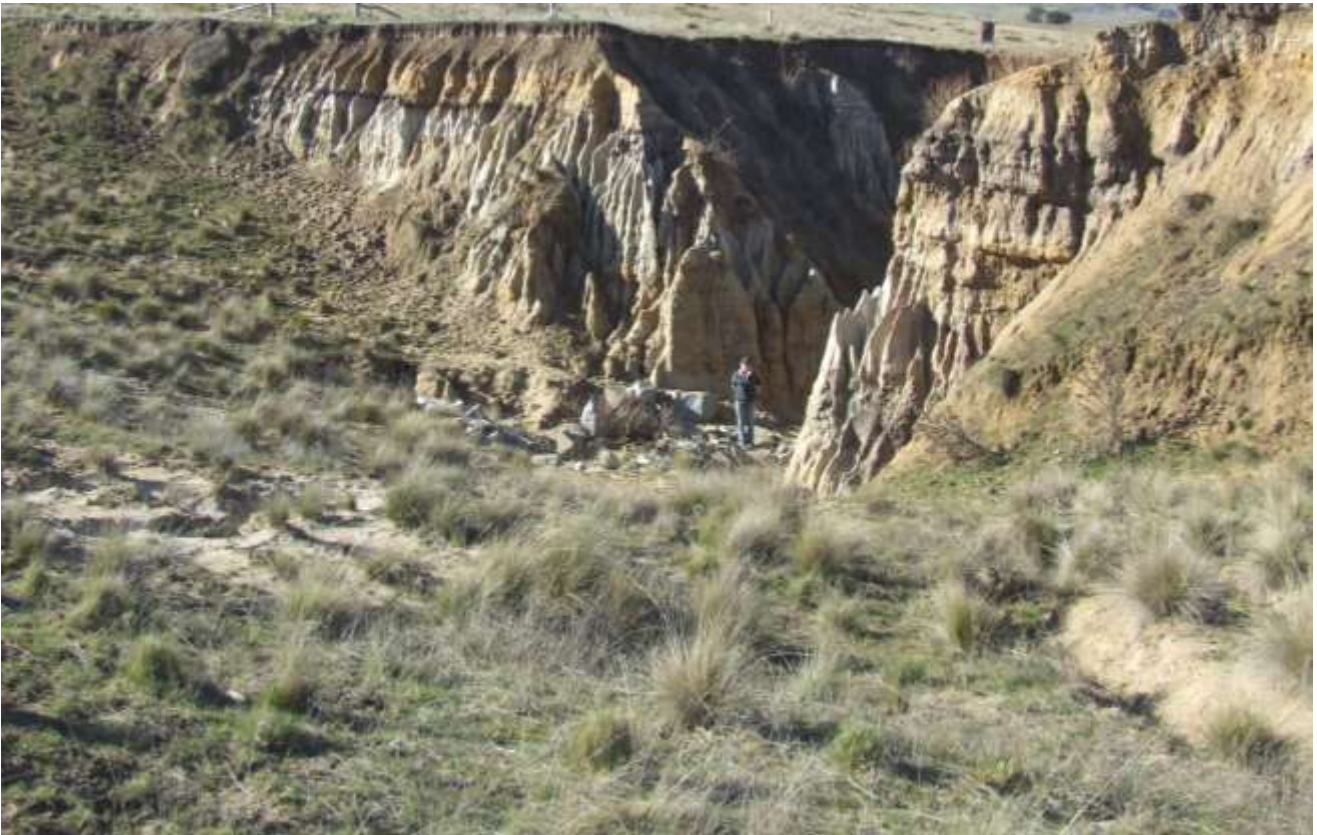
Figure 37b: The same gully ten years on. Grass is beginning to colonise sidewalls as they gradually erode to a more natural incline, although complete colonisation is not likely (photo courtesy Emma Platts 2007).
