# **The Corrowong Wallendibby Erosion and Sediment Control Project 1995-2001: Benchmarking Report**

Prepared 2007 by Emma Platts, on behalf of the Corrowong Wallendibby Landcare Group Inc.

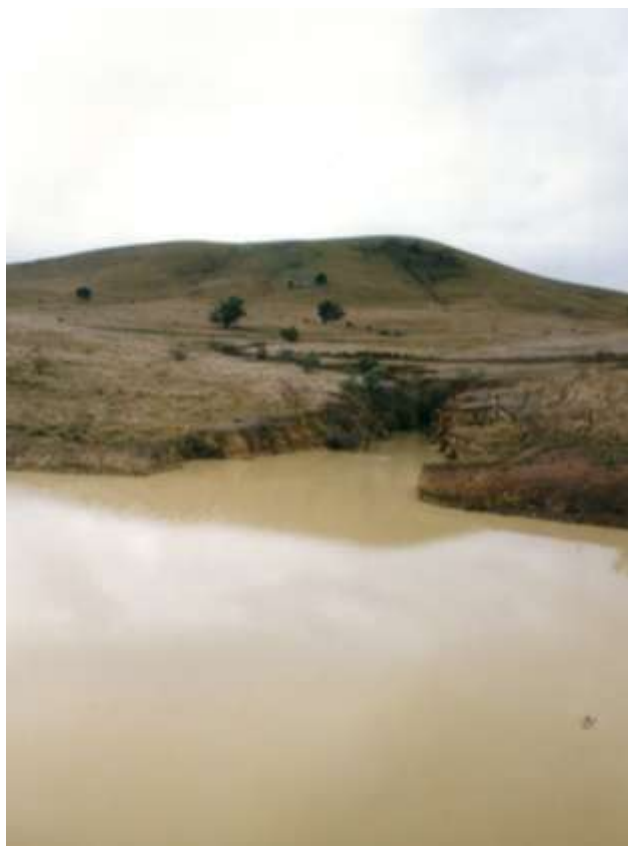
Figure 2: Showing sediment delivery from a gully at Woodborough (date and source unknown).

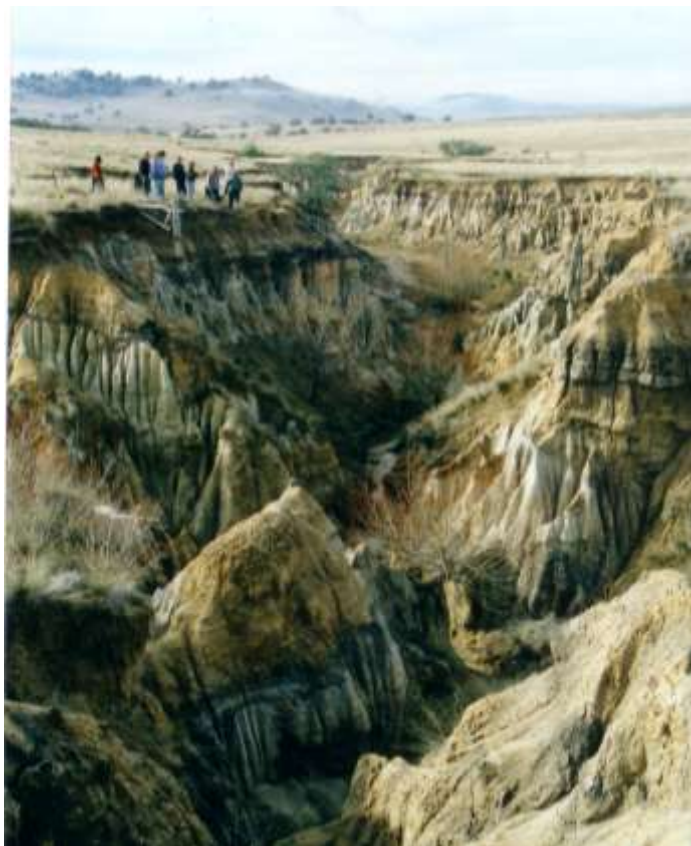
Figure 3: One of the more impressive gullies at Woodborough (date and source unknown).

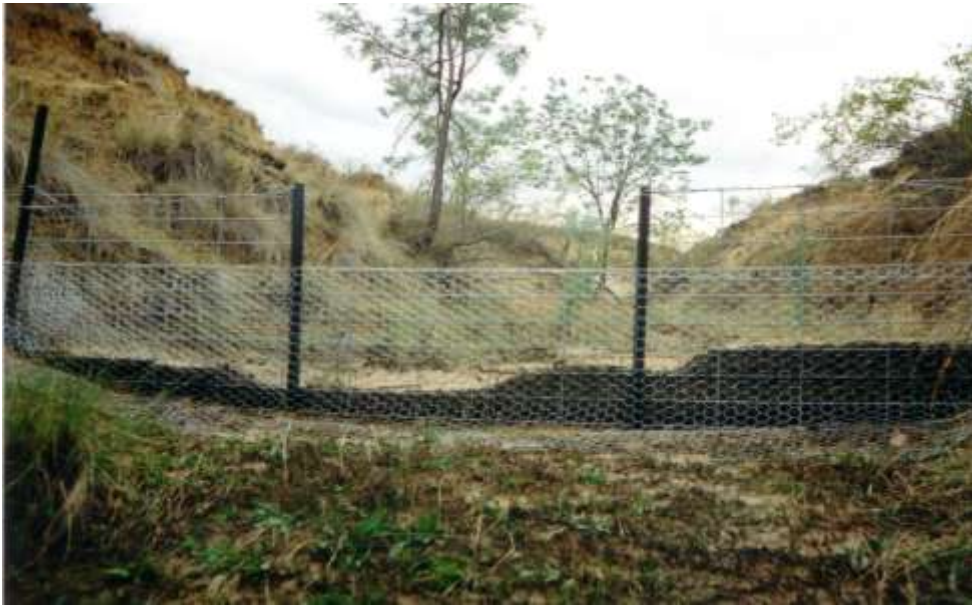
Figure 12: A wire mesh weir at Airlie Park shortly after construction (source and date unknown).

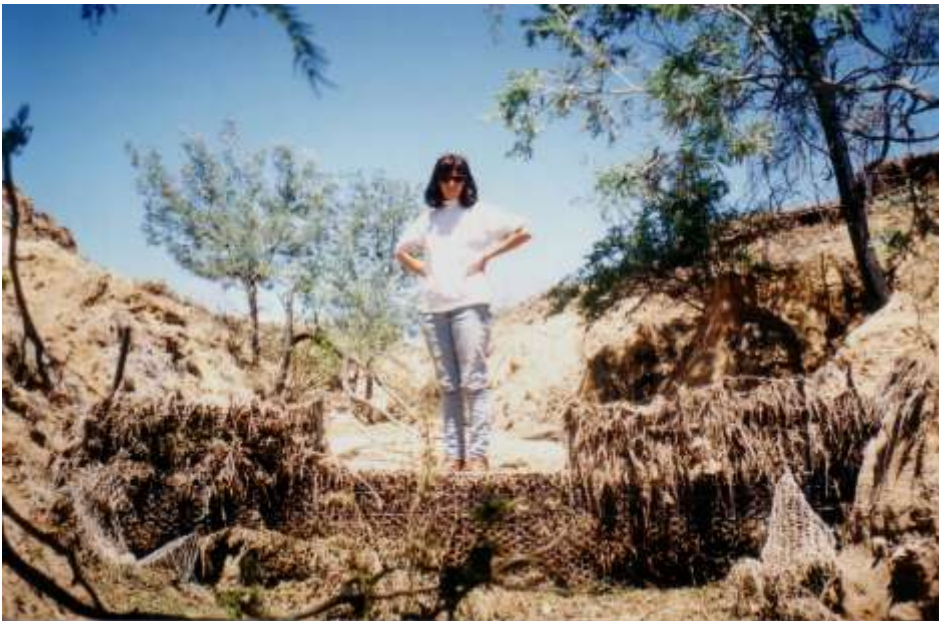
Figure13: Kerry Payten viewing the same wire mesh weir at capacity, immediately after an intense summer storm. Note the effect of raising the level of the gully floor by containing sediment (source and date unknown).

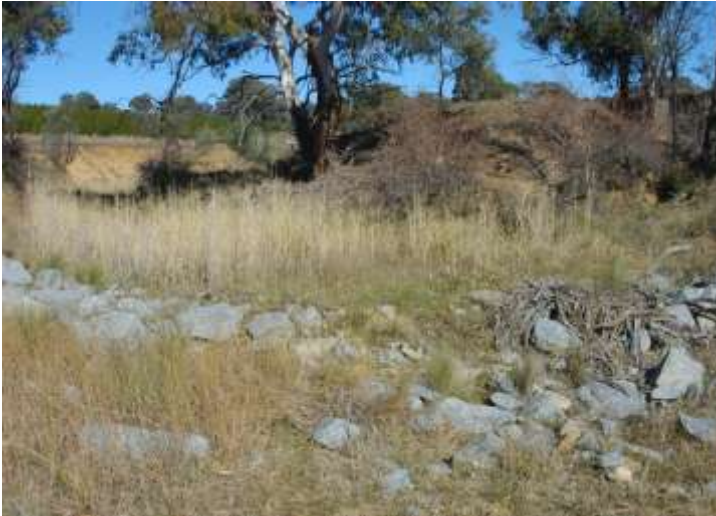
Figure 17a: A rock groyne trapping sediment in conjunction with *Phragmites* (*Phragmites australis*) at Airlie Park (courtesy Sally Anne Thompson 2007). This groyne has been highly successful, elevating the level of the bed with sediment, which has grassed up well. Although there has been some movement of rocks (as to be expected) there has been no significant impact on the structure by overland flow. It should be noted that the control of water by a sediment basin above, is essential in decreasing the

velocity and volume of overland flow (which reduces the challenge to the structure) and affords the gully floor the ability to re-establish revegetation.

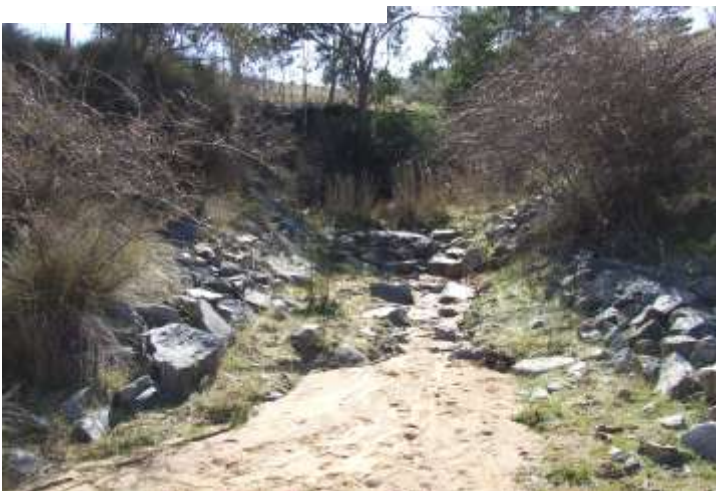
Figure 18: This figure demonstrates the finite capacity of rock groynes in relation to sediment input. This rock groyne at Corrowong, (which plays a final sediment retainment role before water is delivered to Corrowong Creek), is close to sediment capacity. Such a structure would benefit from the installation of a number of wire mesh weirs in the gully line above.

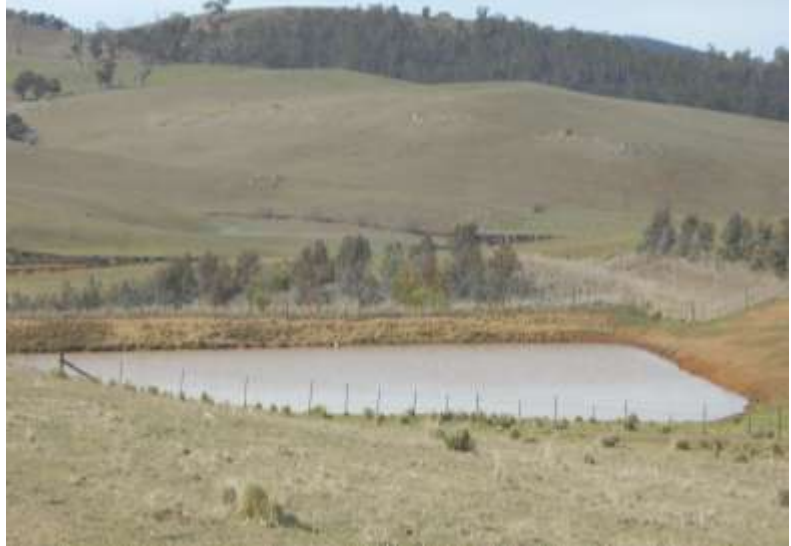
Drought conditions provided less than optimal conditions for dam wall compaction, as demonstrated in **Figure 19** . Despite this all sediment basins (and dams for erosion control purposes) have proved successful1. **Figure 20**. Note the colour of the water, indicating sediment input.

Figure 20: A sediment basin and revegetation at Wallendibby (courtesy Sally Anne Thompson 2007).

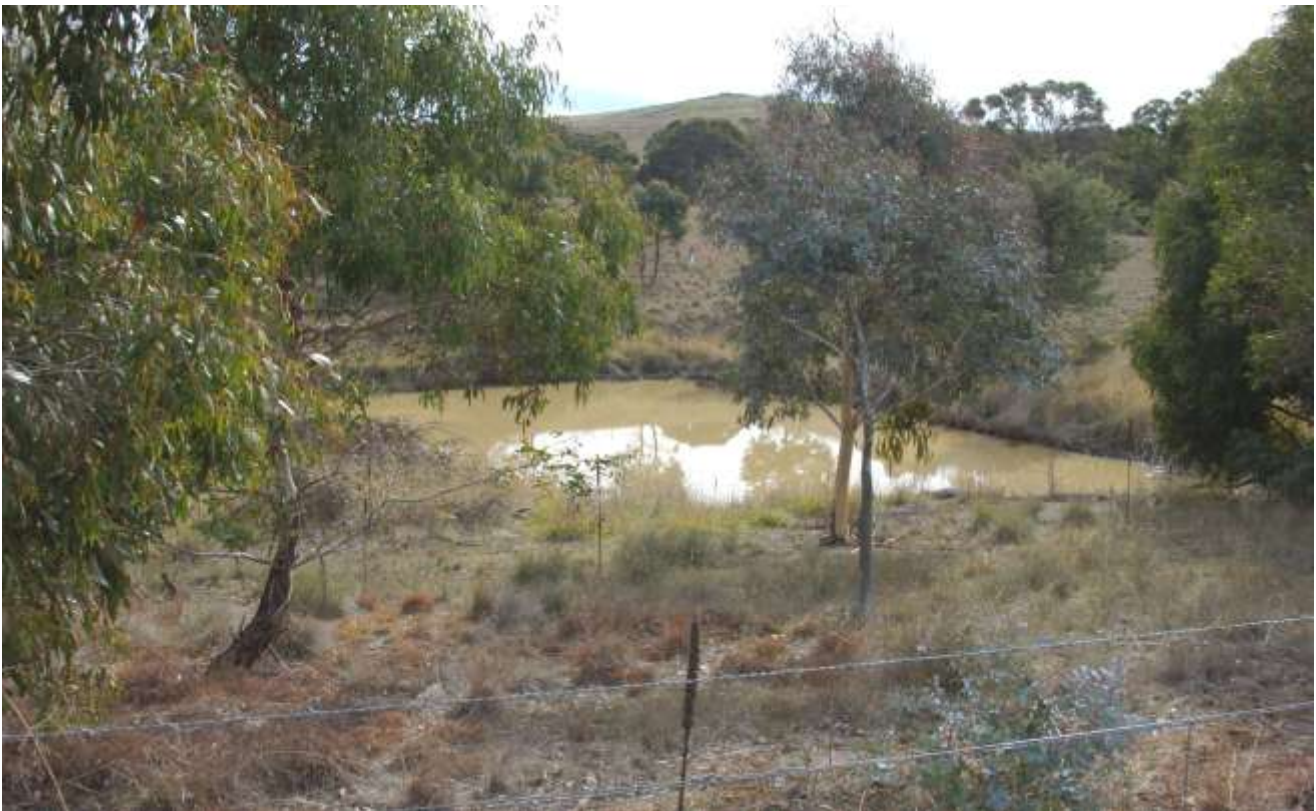
Figure 21: A sediment basin at Airlie Park (figure courtesy Sally Anne Thompson 2007).

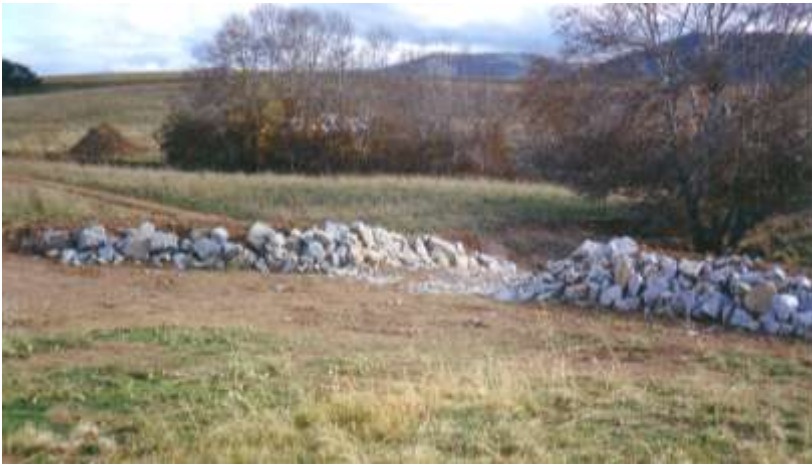
Figure 22: A rock flume after construction at Greenfields (source and date unknown).

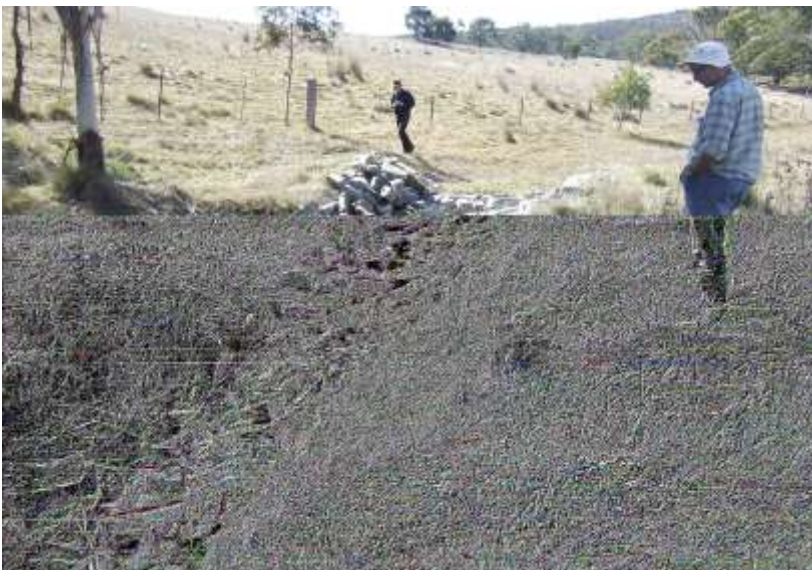
Figure 24: Rowan Wright and Bob Britten survey a successful flume at a Willmott Forests owned property. Such a structure should have reasonable longevity with the incorporation of vegetation (figure courtesy Emma Platts 2007).

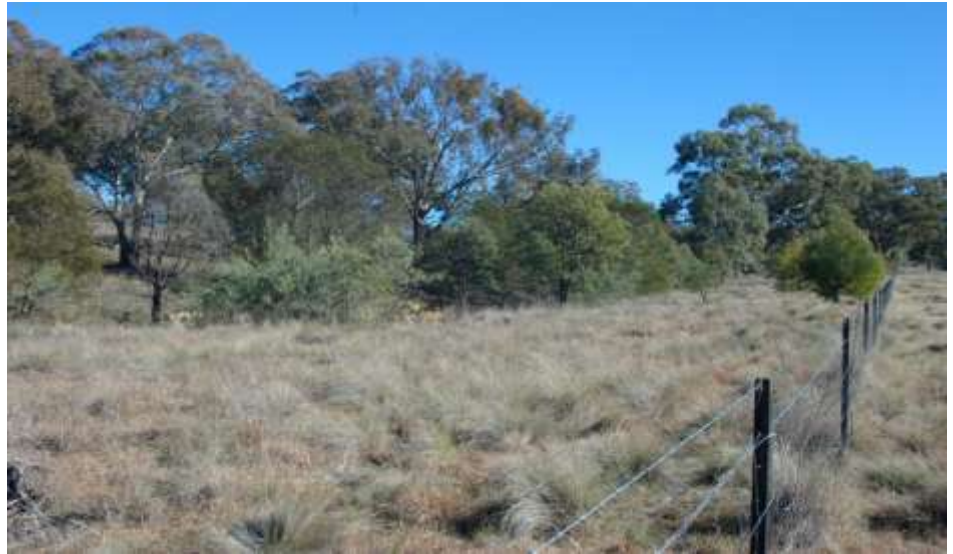
Revegetation is particularly evident where livestock access has been managed, such as that at Airlie Park (figure 27). This gully is experiencing strong growth of native pasture along with native eucalypts and acacia spp.

Figure 27: Revegetation at Airlie Park (courtesy Sally Anne Thompson 2007).

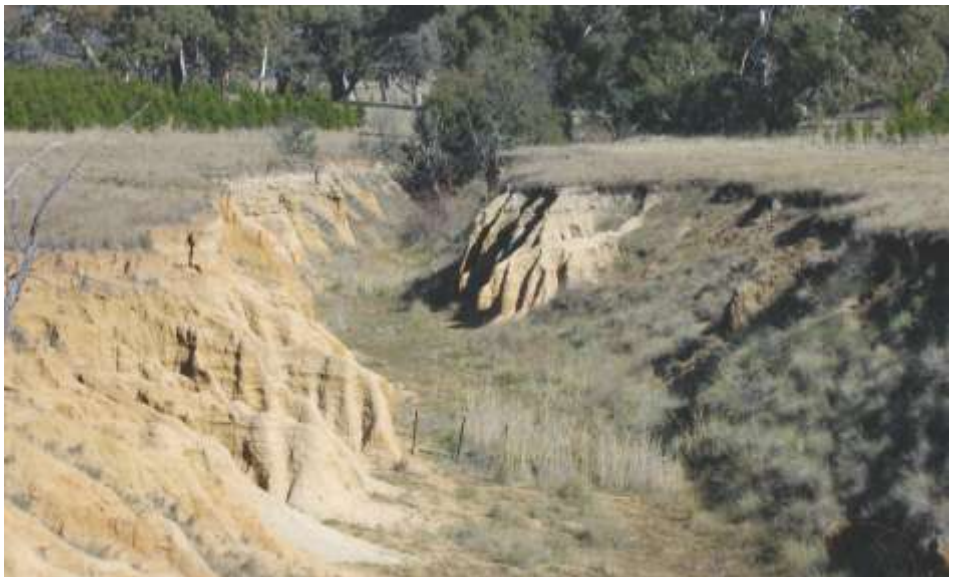
Aspect appears to be a significant factor in grass colonisation of sidewalls (figure 29).

Aspect (in combination with bank grade) plays a significant, although uncontrollable factor in grass re-colonisation (figure 29).

Figure 29: Figure demonstrating natural colonisation as a factor of aspect and bank grade, Airlie Park (figure courtesy Sally Anne Thompson 2007).

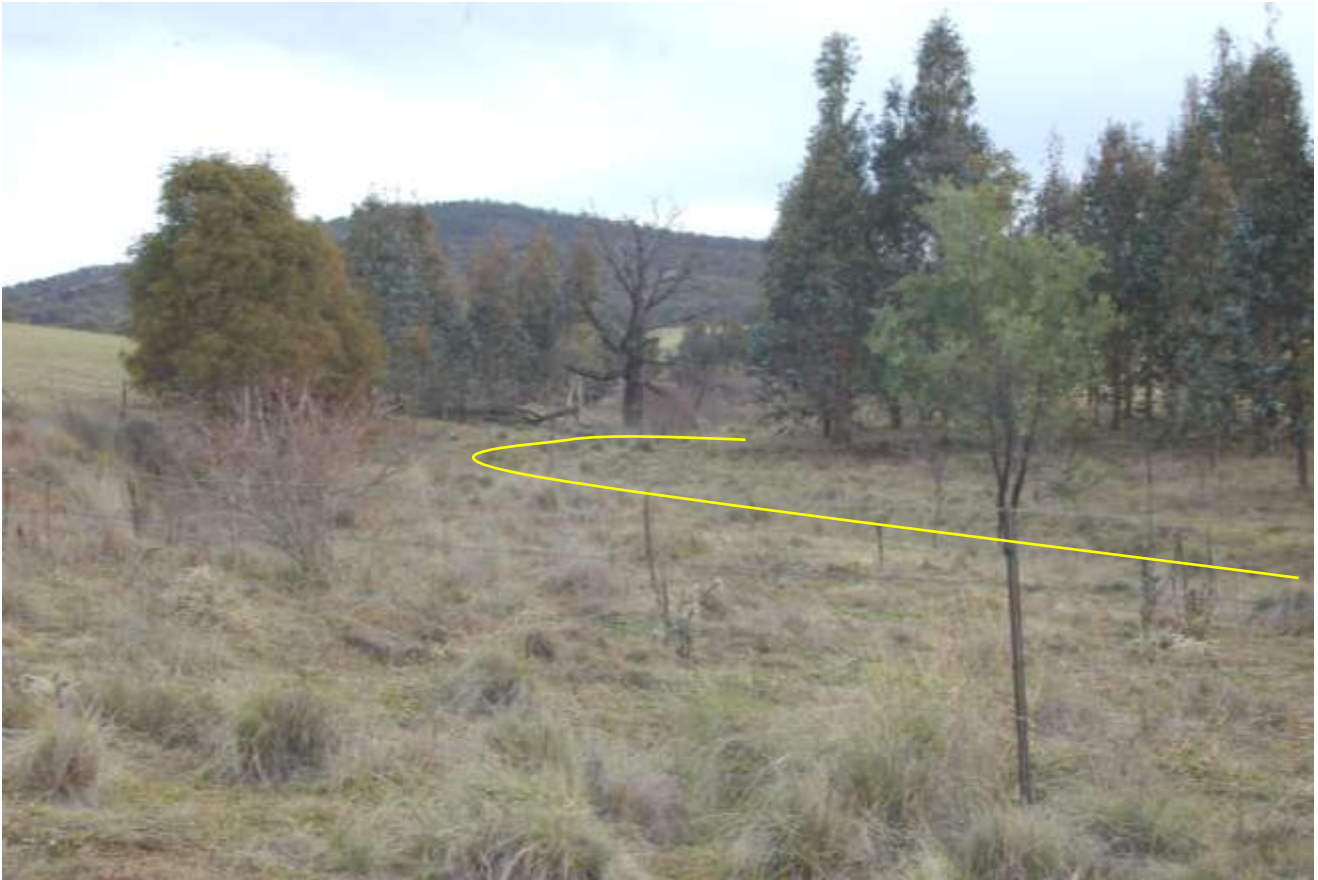
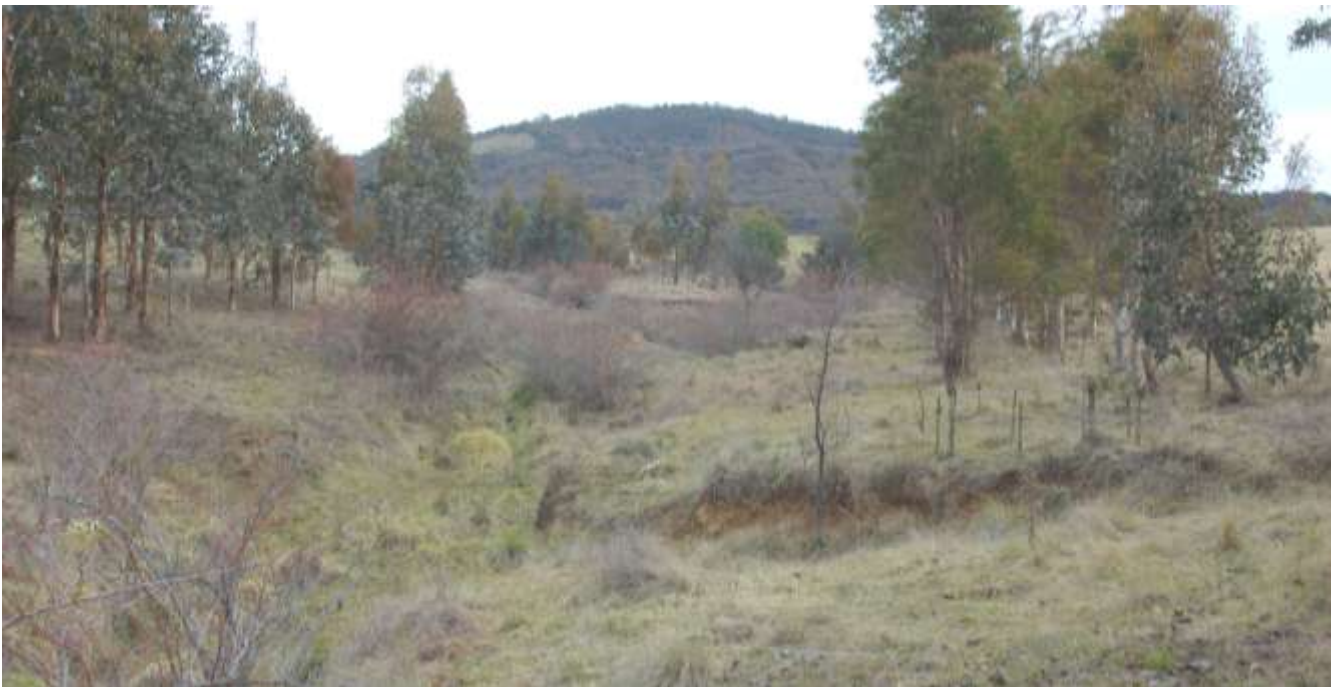
Figures 30a (above) and 30b (below) demonstrate one of the most successful examples of gully rehabilitation of the Section 10 project. This gully at Bimbimbie, demonstrates strong growth of native and introduced pasture species, and native trees, after stock management. The yellow line in figure 30a marks the original gully line (it should be noted that this gully drains a relatively lower energy catchment than many other gullies).

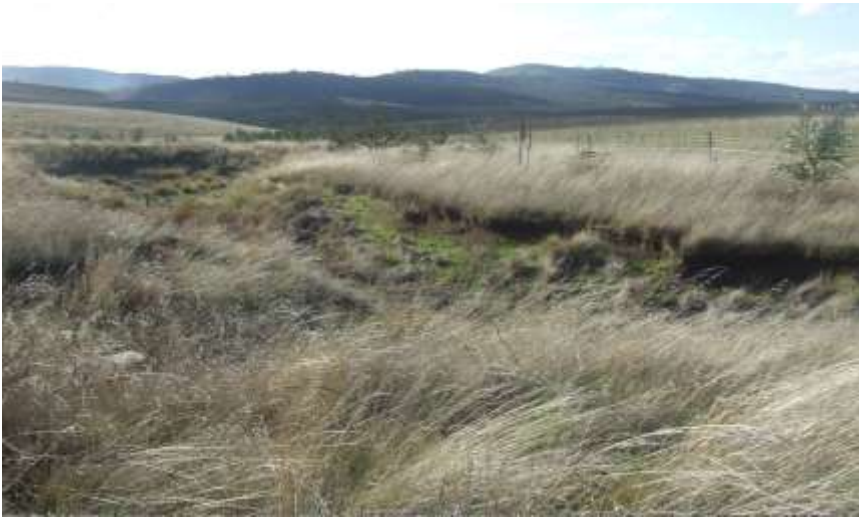
Figure 31: A successful example of grass colonisation at Greenfields. The sidewall of this gully has a subtle angle, affording revegetation when combined with fencing for stock management (figure courtesy Emma Platts 2007).

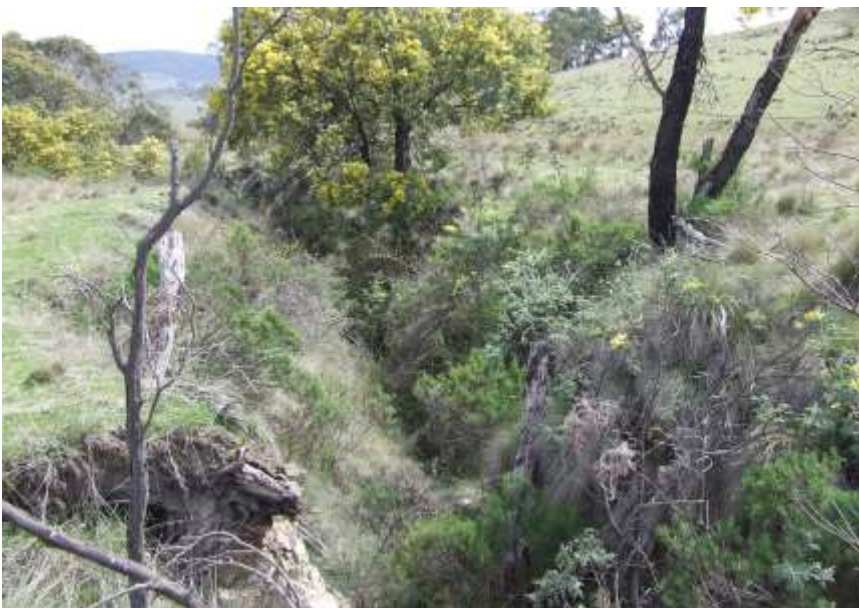
Figure 32: Showing revegetation of a deeply incised gully at Tingaringi. The control of overland flow by a dam in the gully line above has facilitated the growth of revegetation on the gully floor and sidewalls (Figure courtesy Emma Platts 2007).

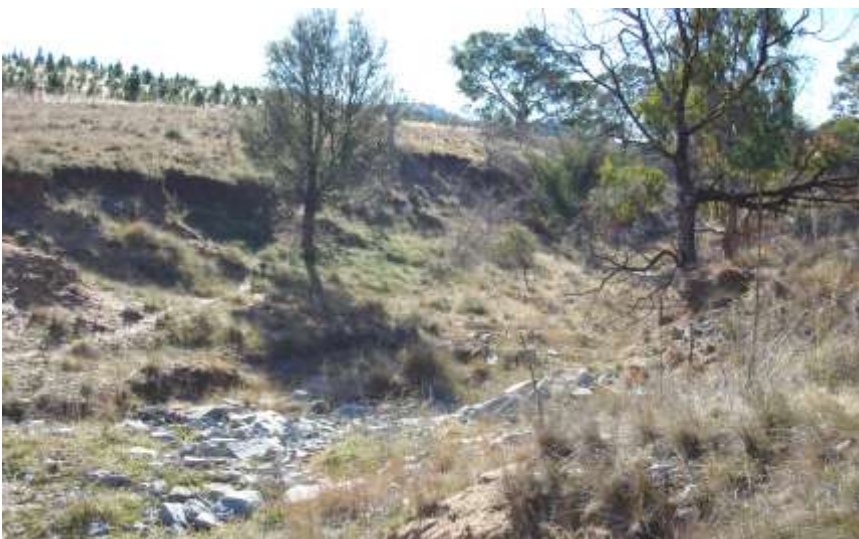
Figure 33: Demonstrates colonisation of grasses on gully floors and sidewalls. Before flow control by a sediment basin and sediment containment by rock groyne, this gully was actively eroding (figure courtesy Sally Anne Thompson 2007).

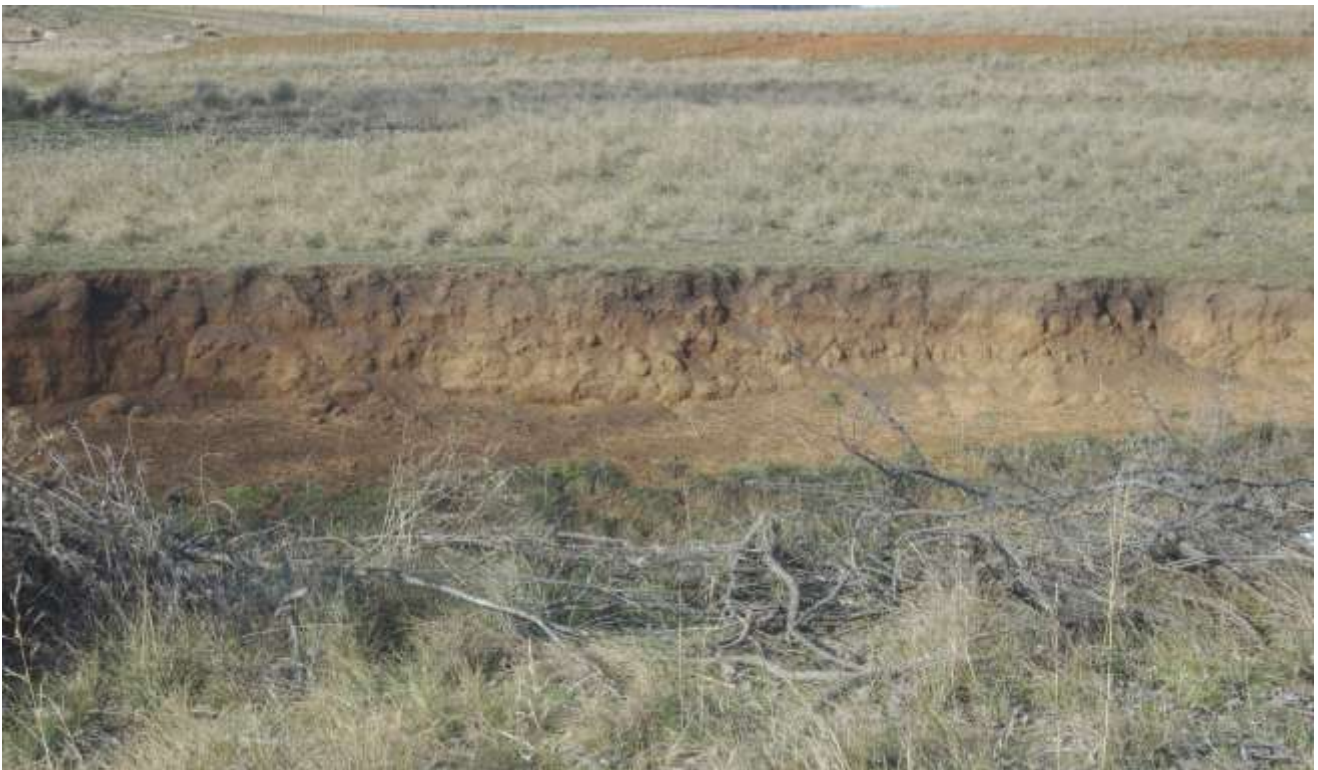
Figure 36: Another example at Greenfields (courtesy Sally Anne Thompson 2007).

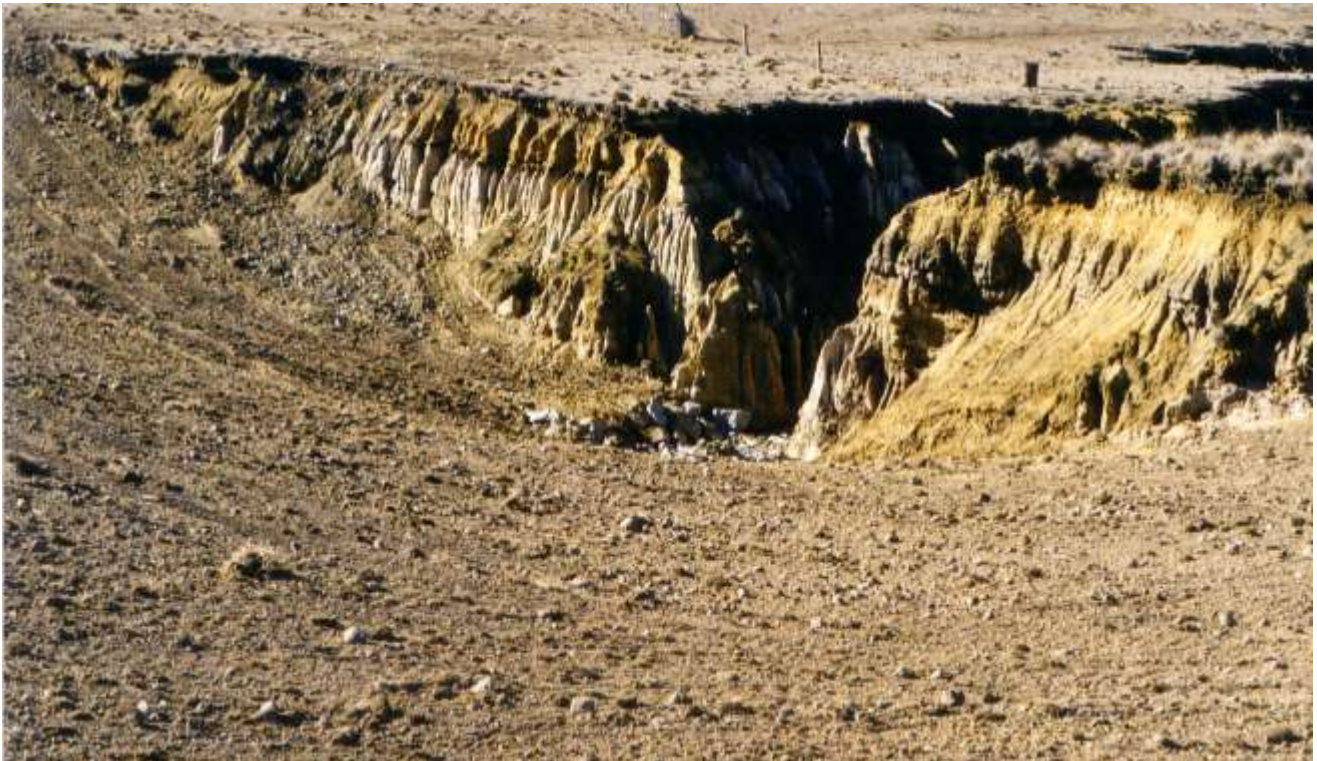
Figure 37a: Battered banks and a rock groyne at implementation, Woodborough (source and date unknown).
